# FLOOD PLAIN INFORMATION

## FLOOD HAZARD REPORT

4-7 JULY 1969 FLOOD

### VERMILION RIVER

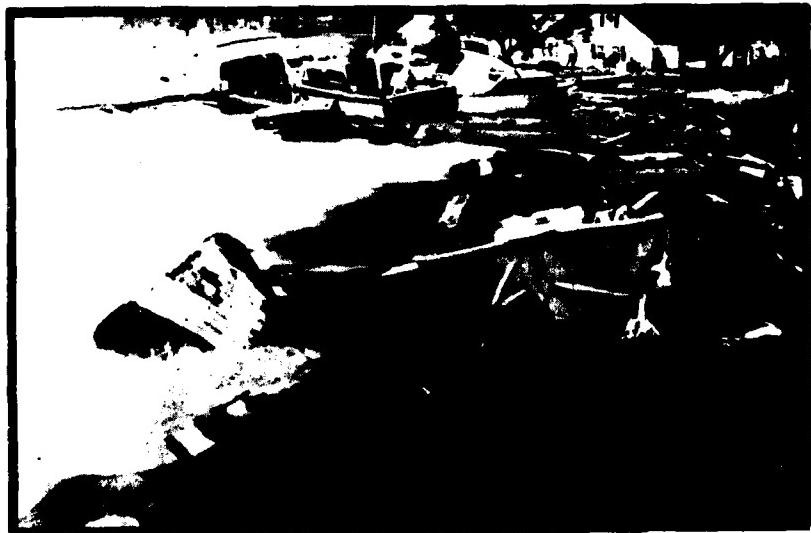
Figure 2 - Looking easterly along lakeshore at wreckage strewn about at the mouth of the river.

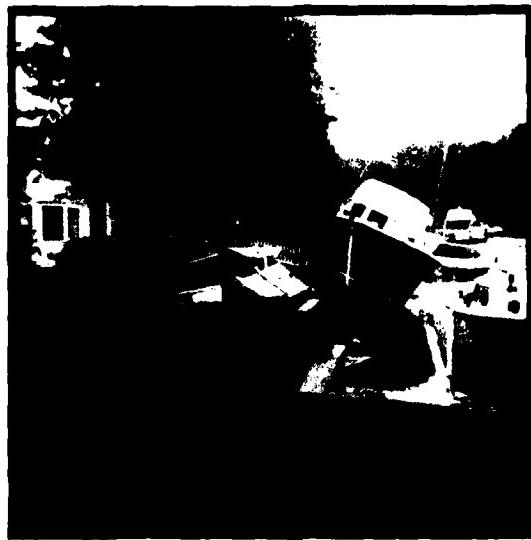
Figure 3 - Typical damage in lagoon area.

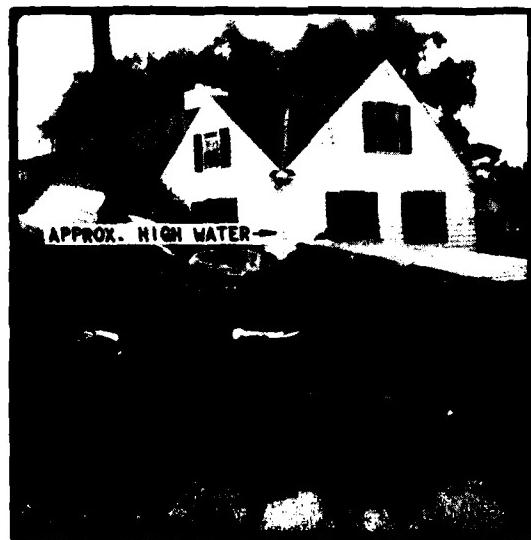
Figure 4 - Typical damage in lagoon area.

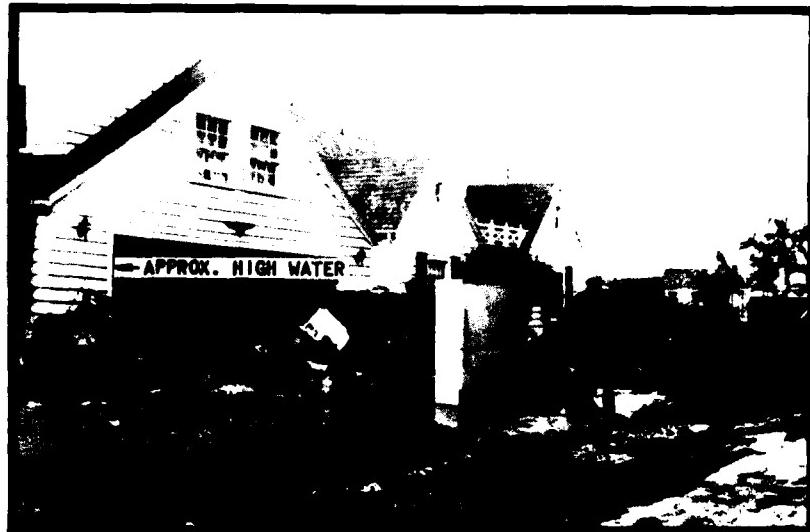
Figure 6 - Typical damage in lagoon area.

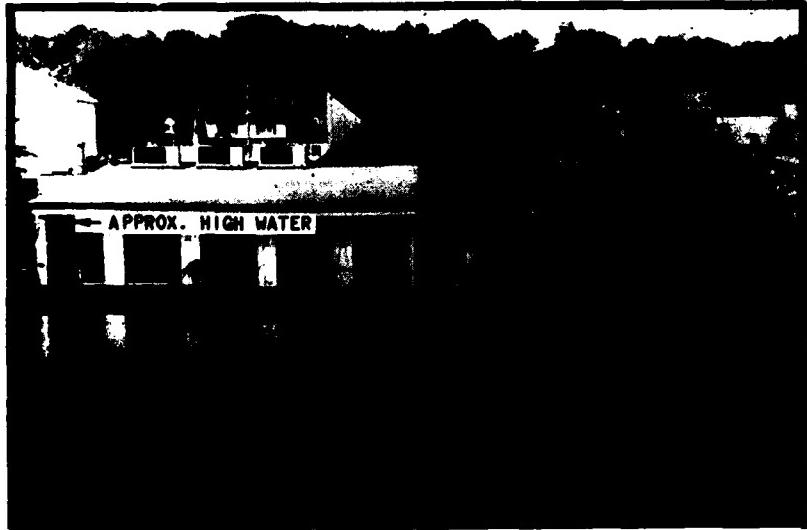
Figure 8 - Looking at McGarvey's Restaurant after flood.

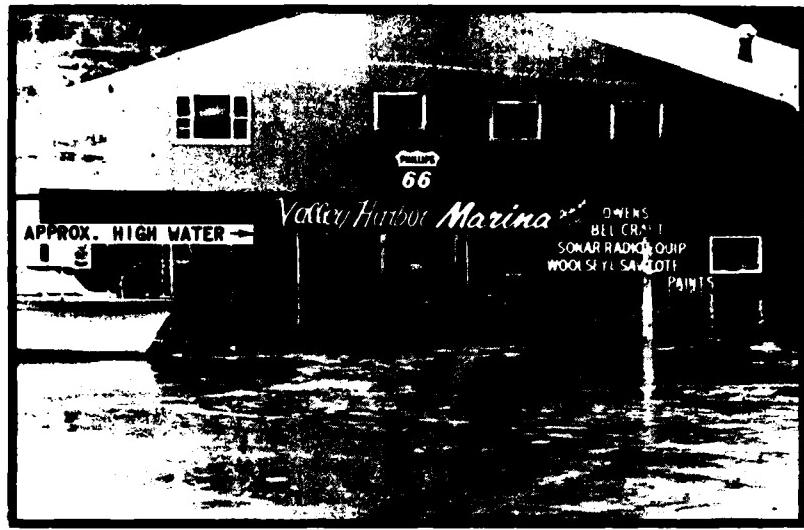
Figure 9 - Looking at Valley Harbor Marina. Water was approximately even with top of showroom windows at the peak.

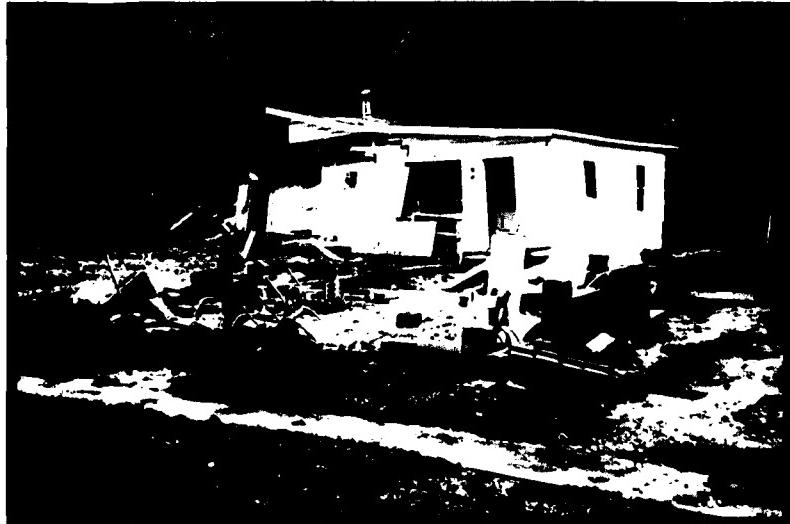
Figure 10 - Looking at typical damage in Olympic Outing Club area. Approximately 1.7 miles upstream from the mouth.

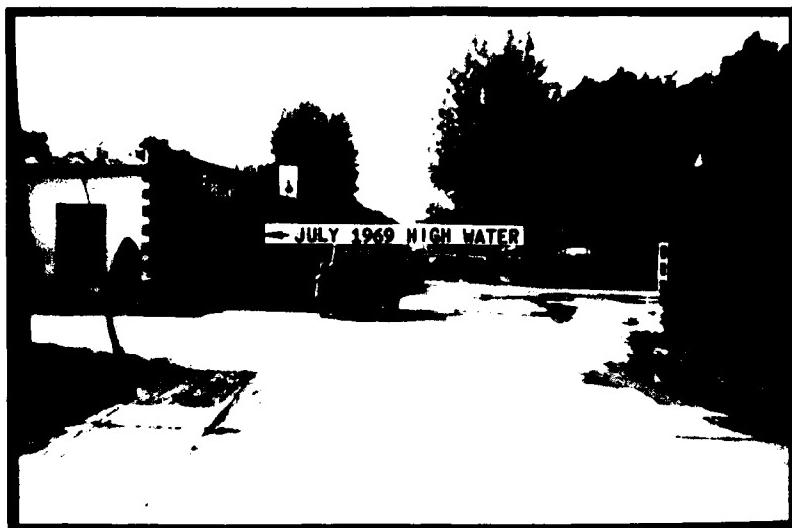
Shown in figure 15 is the Firelands Electric Corporation Inc. Company. The water surface was 4.9 feet above the first floor elevation. Figure 16 is a view of a demolished spillway of a private reservoir just upstream of Chenango Road.

Figure 15 - Skellenger Creek: Water was 4.9 feet above the threshold at the front door. Just upstream of the Penn Central Co. Railroad.

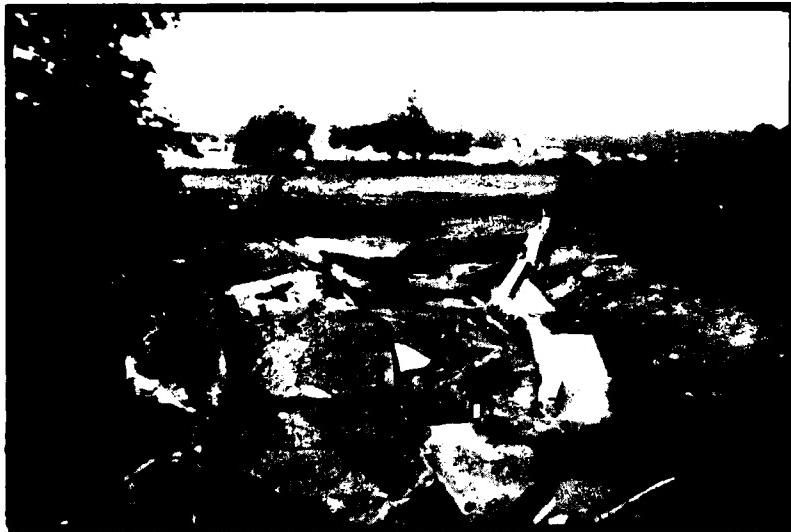
Figure 16 - Bonney Creek: Spillway washout on a private reservoir upstream of Chenango Road in New London.
